UH-1 ACCIDENT SUMMARY

Majors, Minors,
Incidents,
Forced Landings,
Precautionary Landings

1 JULY 1960 THROUGH
30 JUNE 1965

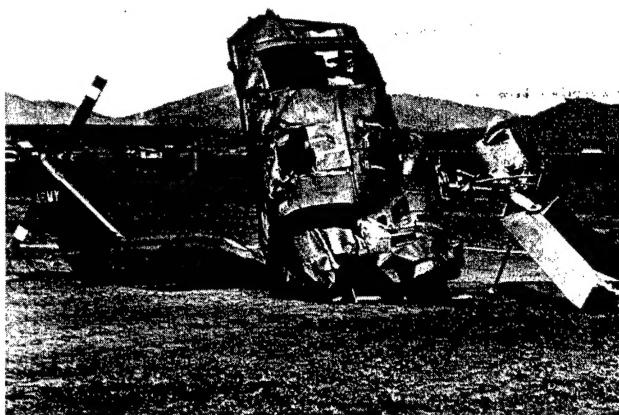
07747

07747--Pilot attempted right turn during zero airspeed autorotation. Aircraft would not respond to flight controls and pilot lowered nose and applied

throttle. Engine failed to respond and aircraft landed hard, bounced, and came to rest on right side. Loss of power caused by improper installation of support bearing on left end of throttle linkage torque tube. During installation of support bearing, retaining nut was screwed down too tight, shearing 3/32" rivet and pulling the shaft of torque tube to approximately half its normal engagement.

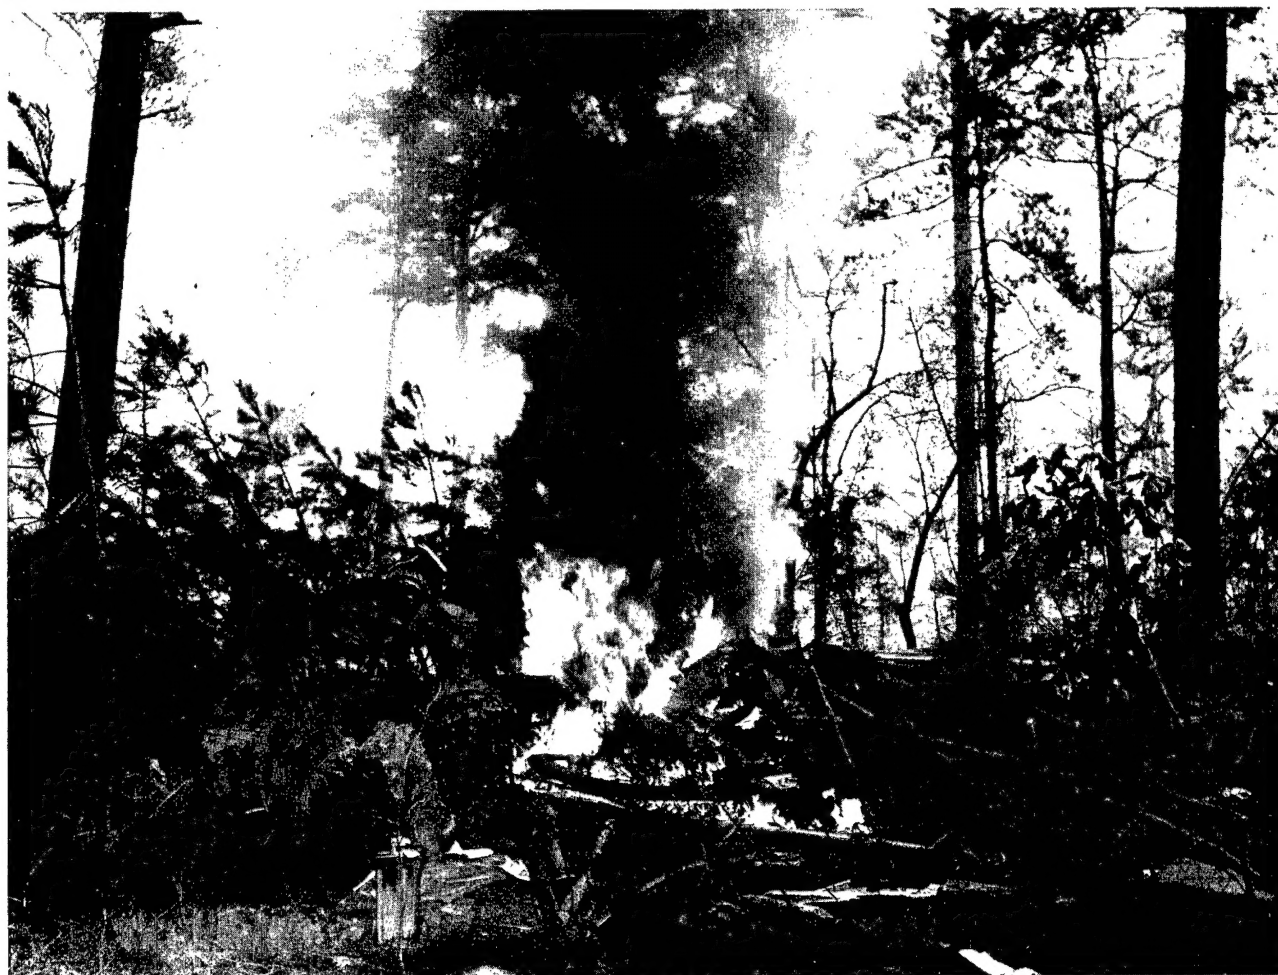
07441

07441--Aircraft crashed into trees and burned during attempted move through dense fog from one heliport to another. Pilot and crewchief killed. Caused by non-instrument rated pilot attempting flight with zero ceiling, totally obscured sky, and 1/16 mile visibility in fog. Crewchief was not wearing protective helmet or gloves.

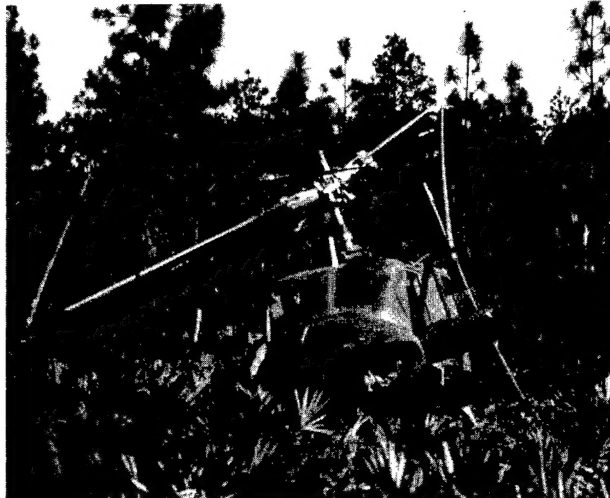
08295

08295--Pilot landed aircraft in confined area and picked up nine passengers during field exercise. Rotor rpm was lost during takeoff and main rotor blades struck trees. Aircraft landed hard, turning 180° to right. Crewchief and four passengers sustained scratches and bruises. Caused by assigning inexperienced pilot to mission beyond his capability, pairing inexperienced pilots, and exerting excessive command pressure on subordinate commanders to fly a maximum number of aircraft for a field exercise. Pilot had not completed transition checkout. Inadequate training of ground personnel resulted in selection of poor landing site.

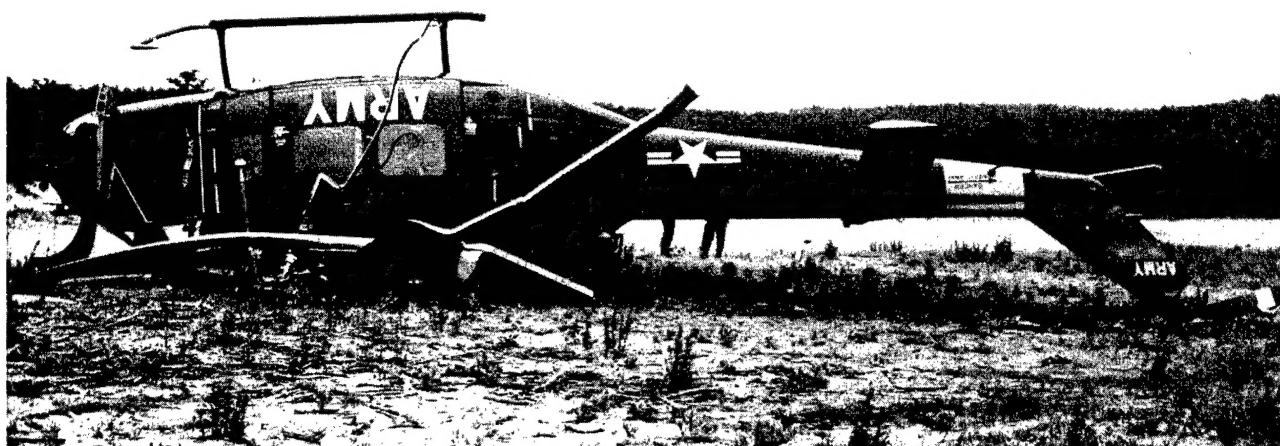
08371

08371--Aircraft drifted left, struck rise in ground, rolled, and came to rest inverted during attempted night landing from hover. Pilot, copilot, and two

passengers sustained minor injuries. Caused by loss of ground reference due to blowing dust. Heavy-left lateral CG due to seating of three passengers on left side and one on right was contributing factor. No ground guide was available.

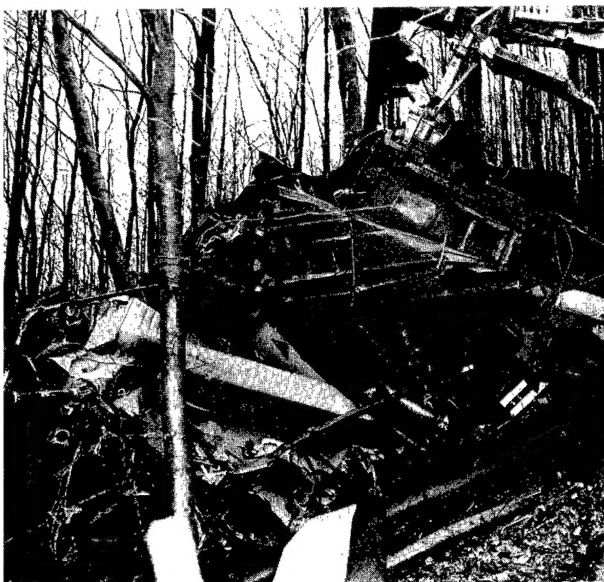
B813

B813--Aircraft flew into clouds and crashed on hillside approximately 2,400 feet above sea level. Pilot was killed and copilot seriously injured. Caused by attempting VFR flight in IFR weather. Contributing factors were: 1. Filing direct VFR flight plan into forecast instrument conditions. 2. Continued flight under weather conditions below authorized VFR minimums. 3. Low level flight under marginal weather conditions over mountainous terrain not familiar to pilots. 4. Flight into low ceiling and visibility conditions without appropriate reduction of airspeed. 5. Absence of IFR facilities at one station and inoperative VHF radio at another station influenced pilot's decision to proceed VFR. 6. False sense of urgency to complete mission contributed.

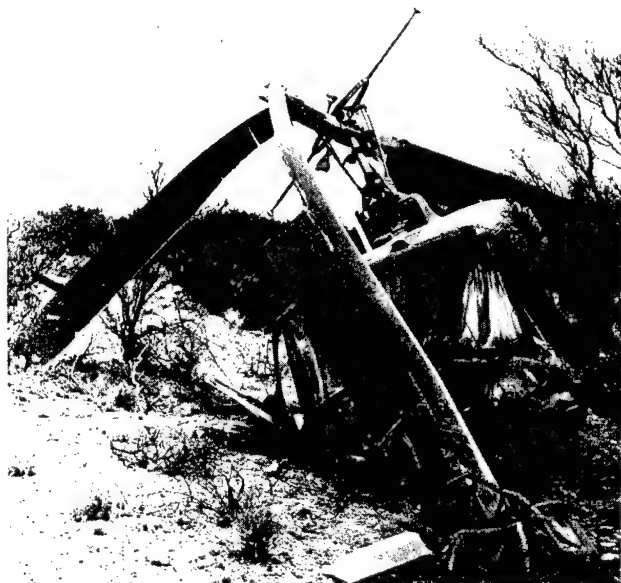
C058

C058--Severe vibration was followed by loud bang and loss of tail rotor control at 900 feet. Air-

craft hit on tail boom and right skid. Loss of tail rotor control caused by fatigue failure of bolt that connects pitch change link assembly to white tail rotor grip.
